A Diagnostic Challenge:

Cervical Spine Injuries in Children

University of Michigan
Program for Injury Research and Education

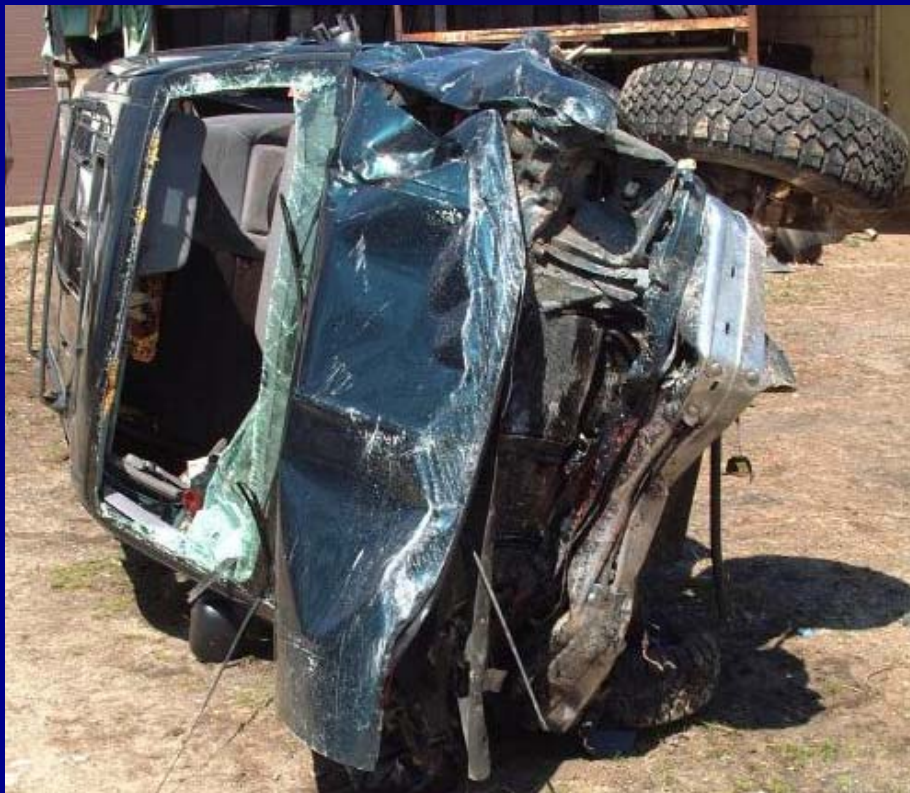
Case Vehicle - 1994 Ford Explorer

Case vehicle as found in the tow yard - representative of FRP

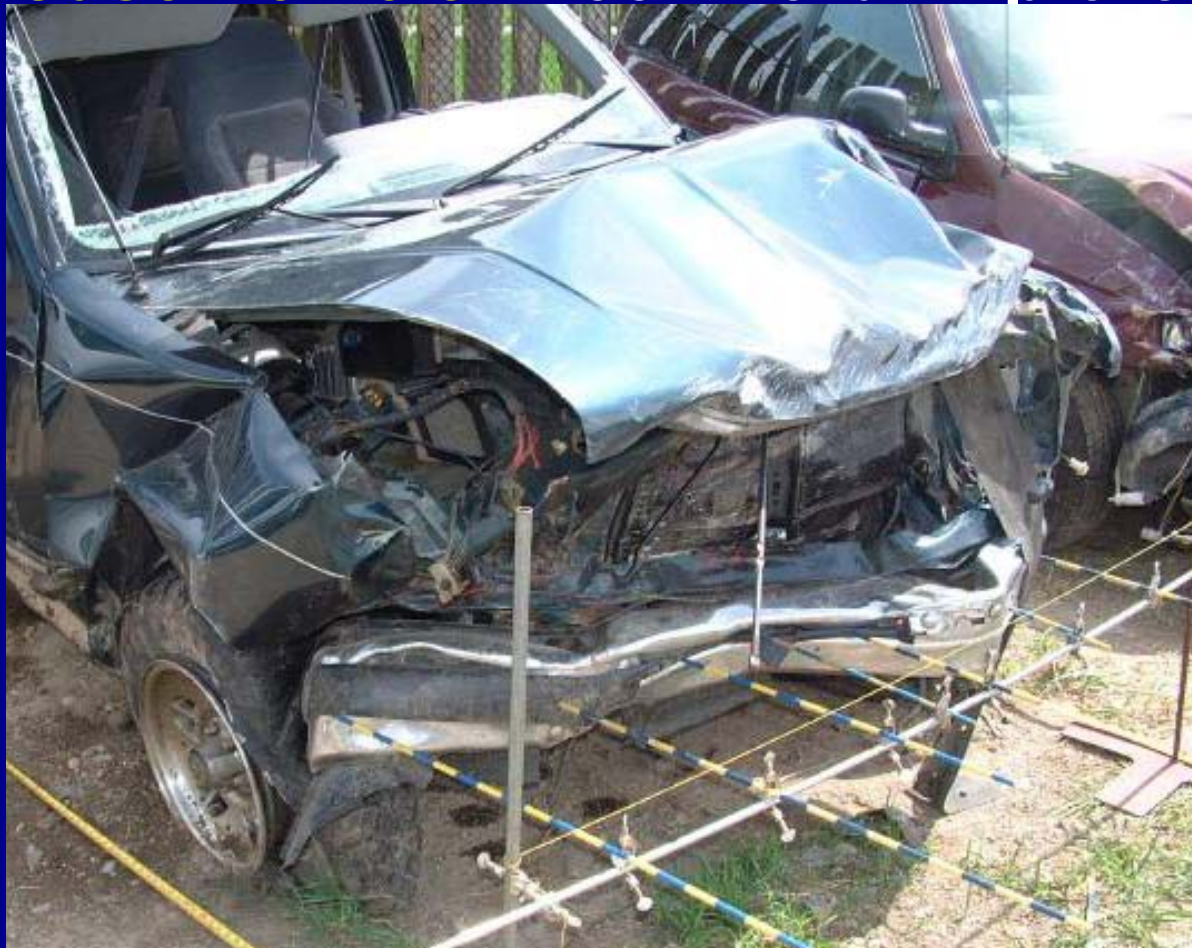
Impact #1

CDC :	12-FDEW-3
Direct damage length:	157 cm
Max Crush:	49 cm
PDOF:	350 degrees
Severity:	28 mph ΔV

- 28 longitudinal
5 lateral

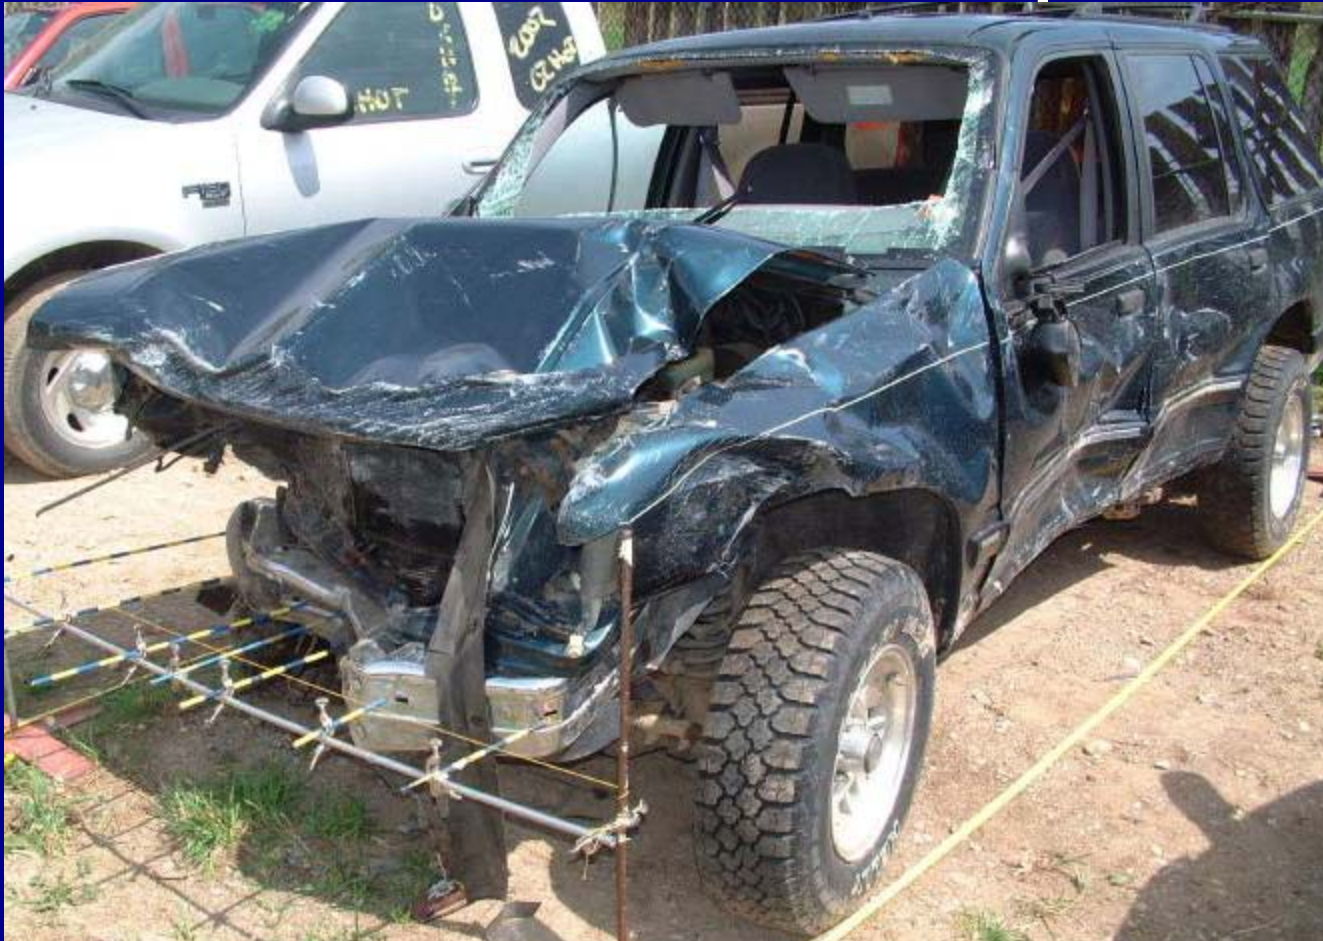
Impact #2

CDCs :

Direct damage length:

Max Crush:

PDOF:

Severity:

09-LYAW-3

214 cm

10 cm

270 degrees

6 mph ΔV

**0 longitudinal
+6 lateral**

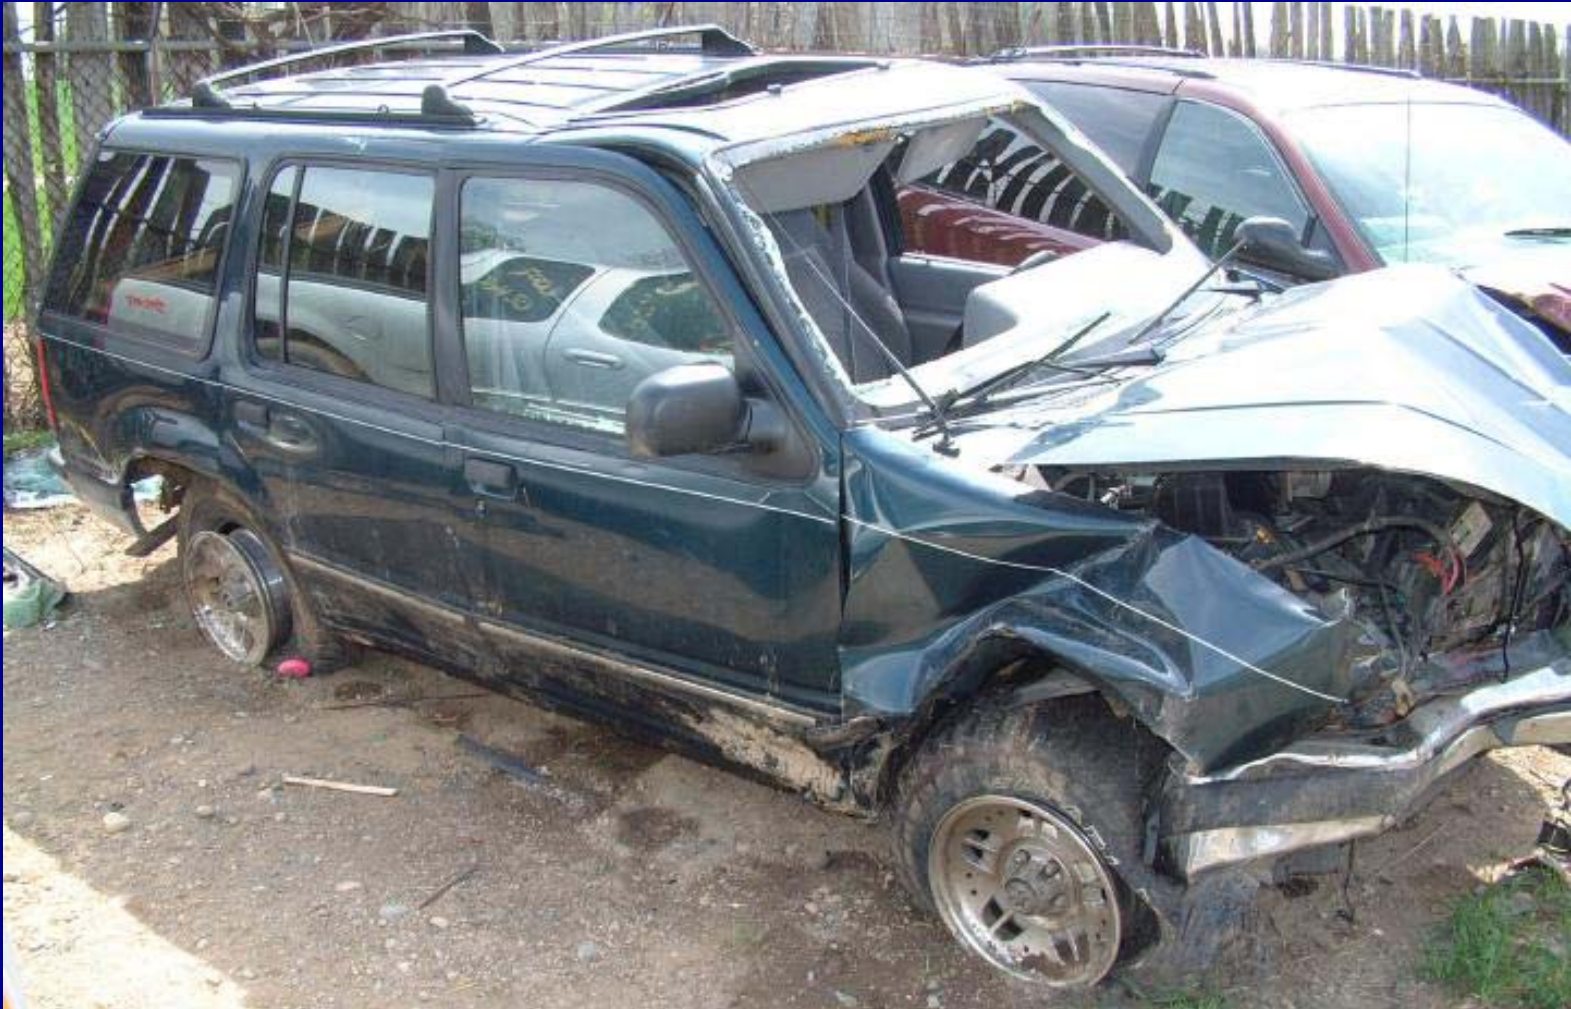
Impact #3

CDCs :

Direct damage length:

Max Crush:

PDOF:

Severity:

00-RDA0-2

409 cm

less than 1 cm

non-horizontal

minor

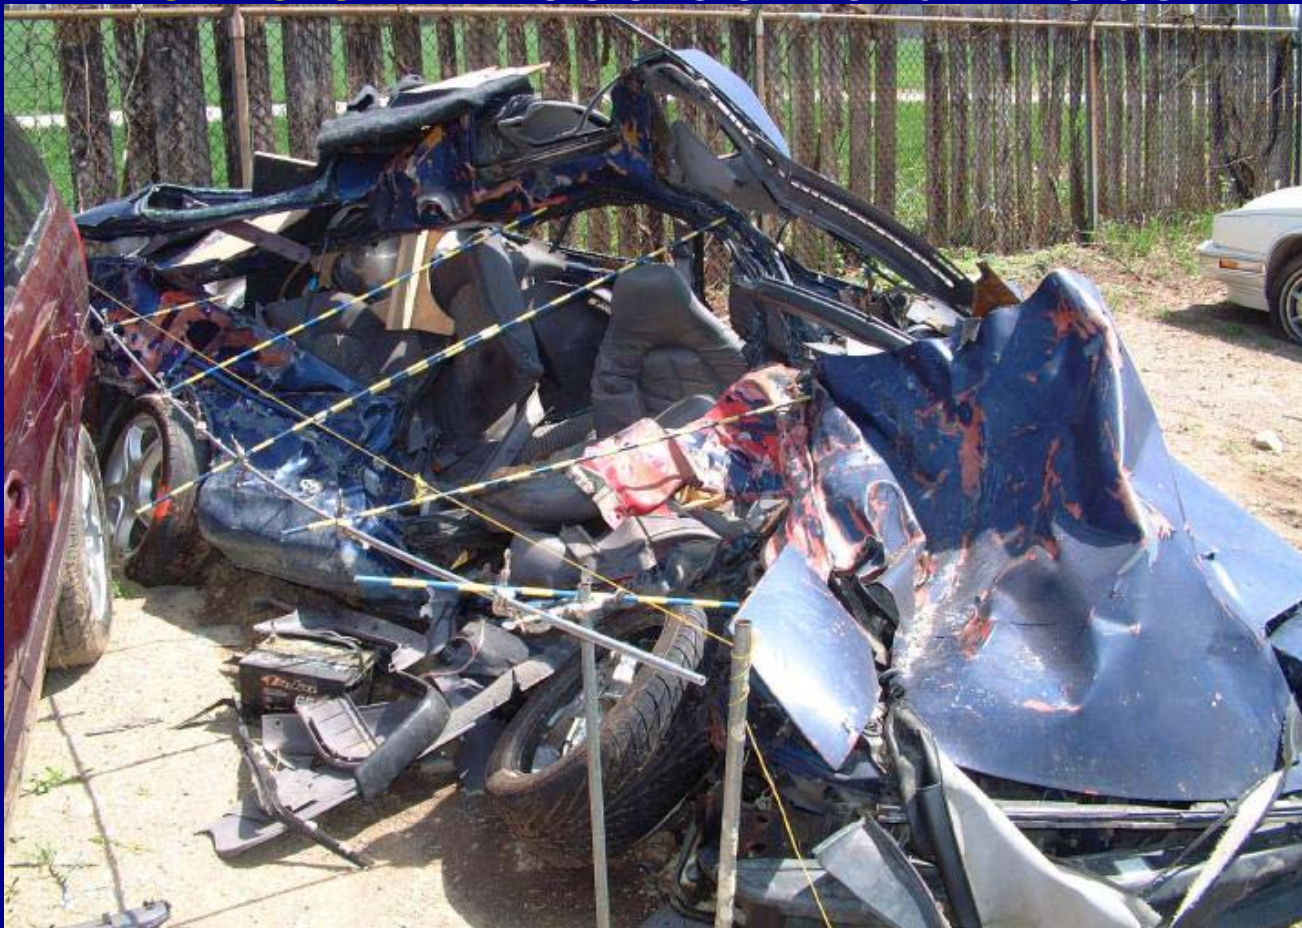
Vehicle 2 - 1993-95 Ford Probe

CDC :	12-RDAW-5
Direct damage length:	310 cm
Max Crush:	98 cm
PDOF:	70 degrees
Severity:	40 mph ΔV

-14 longitudinal
- 38 lateral

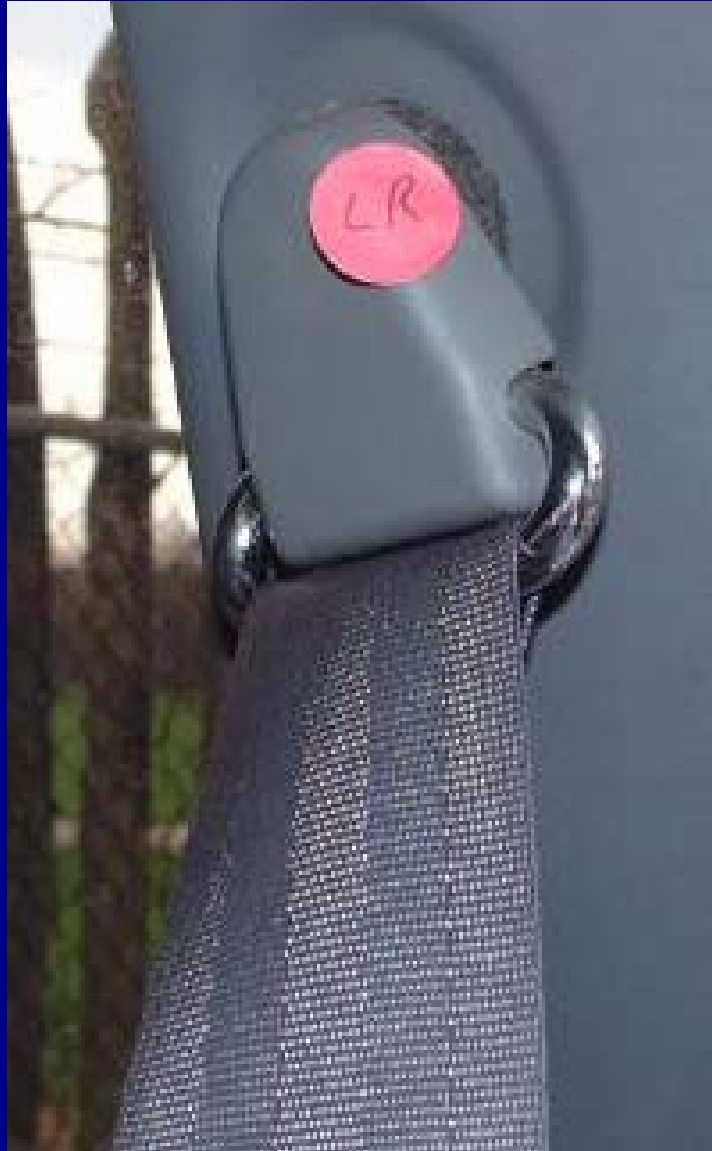
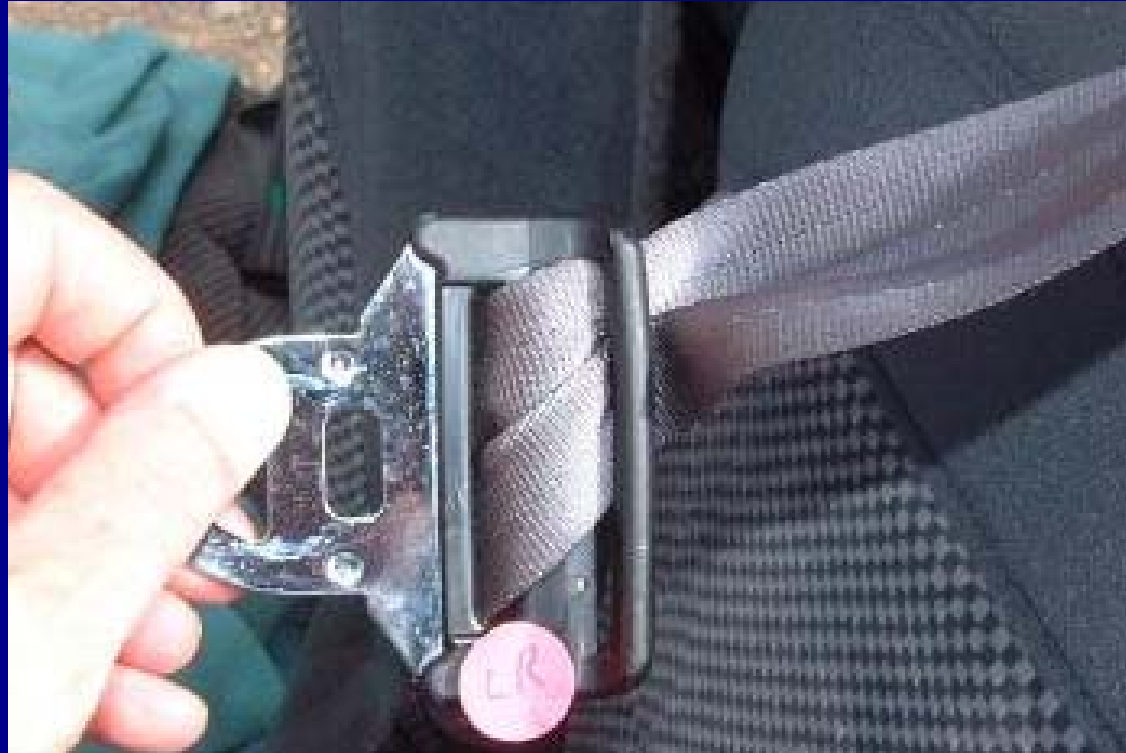
Left Rear - 1994 Ford Explorer

- left rear
- 3-year-old male
- 3 ft 3 in tall
- 33 lb
- 3-point manual belt worn with shoulder belt behind back
- No intrusions

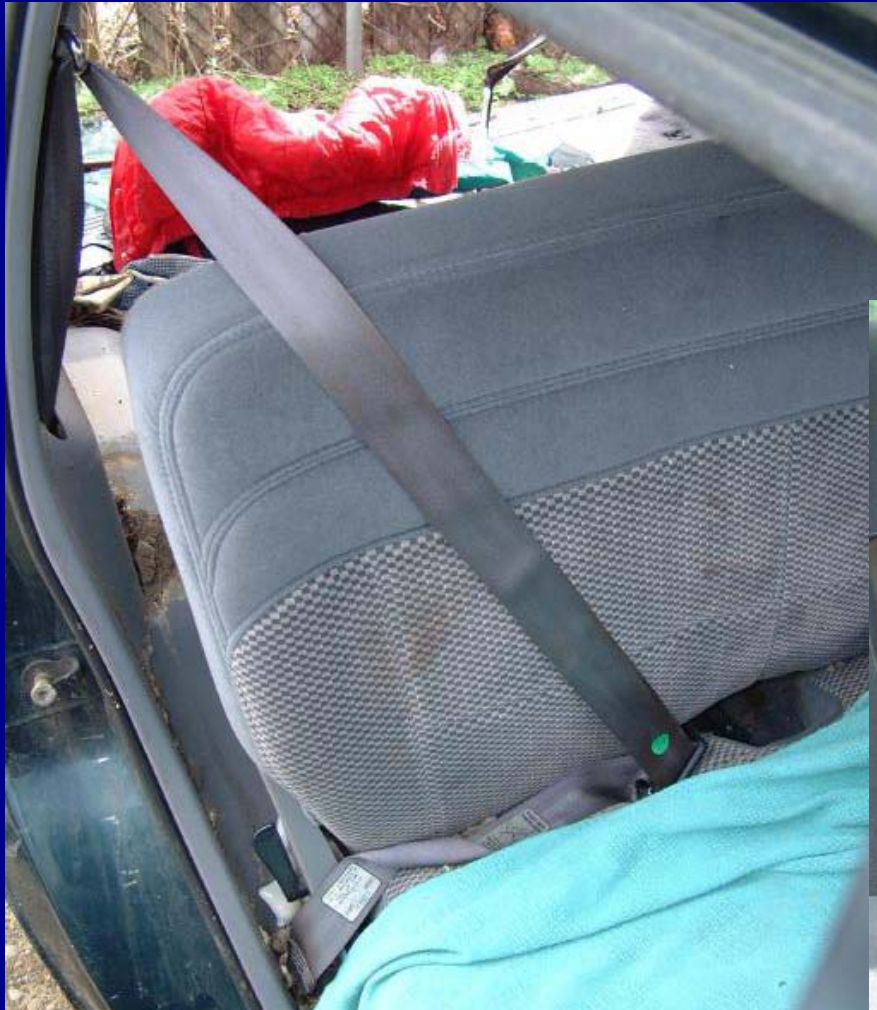
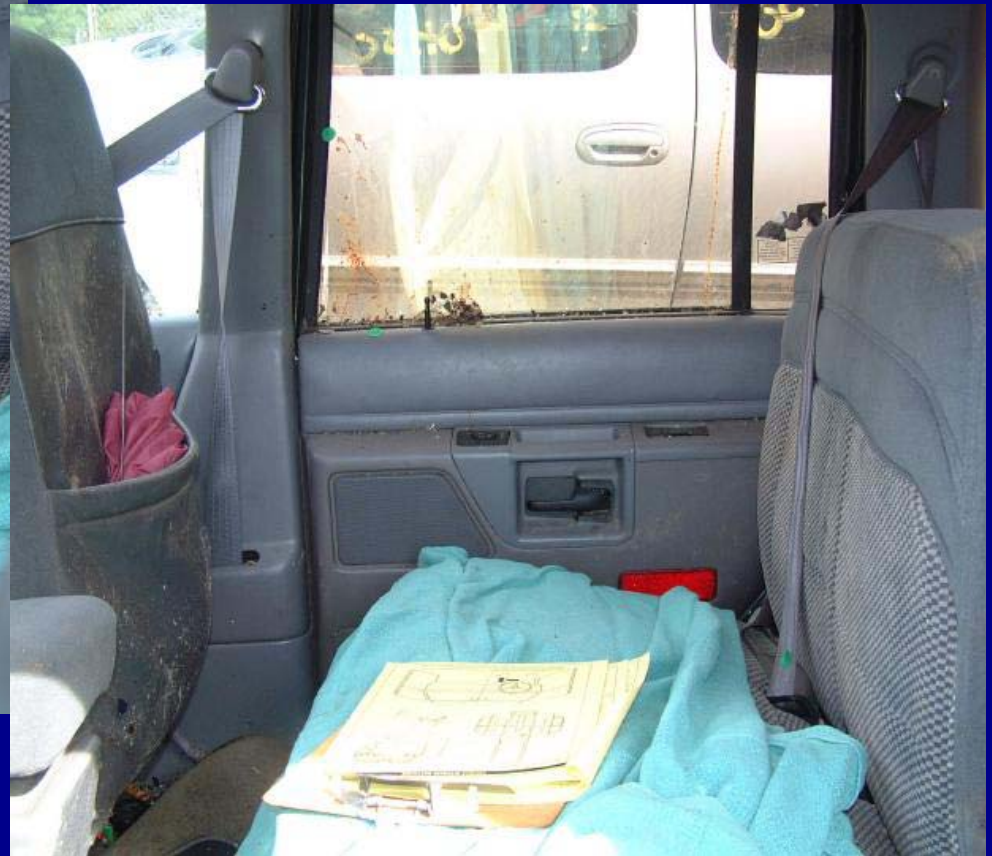
Right Rear - 1994 Ford Explorer

- right rear
- 6-year-old male
- 4 ft tall
- 50 lb
- 3-point manual belt worn with shoulder belt behind back
- No intrusions

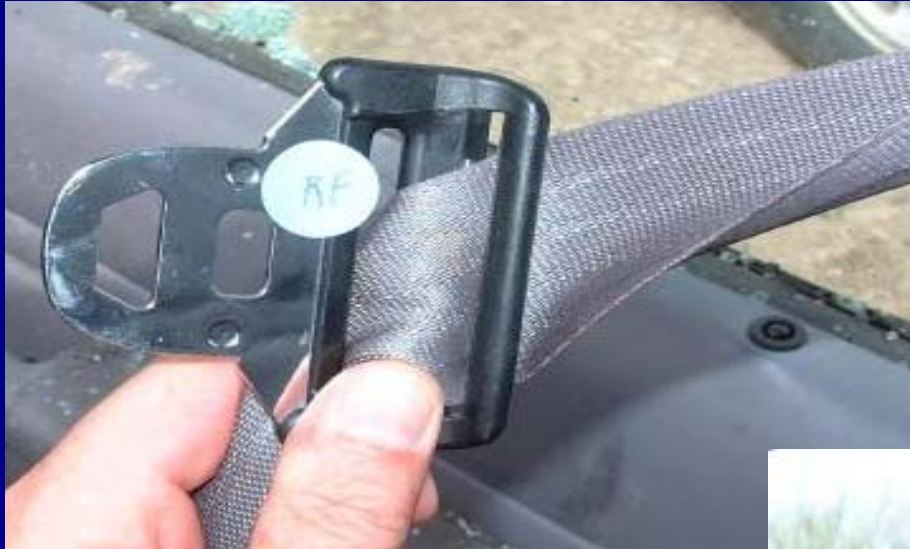
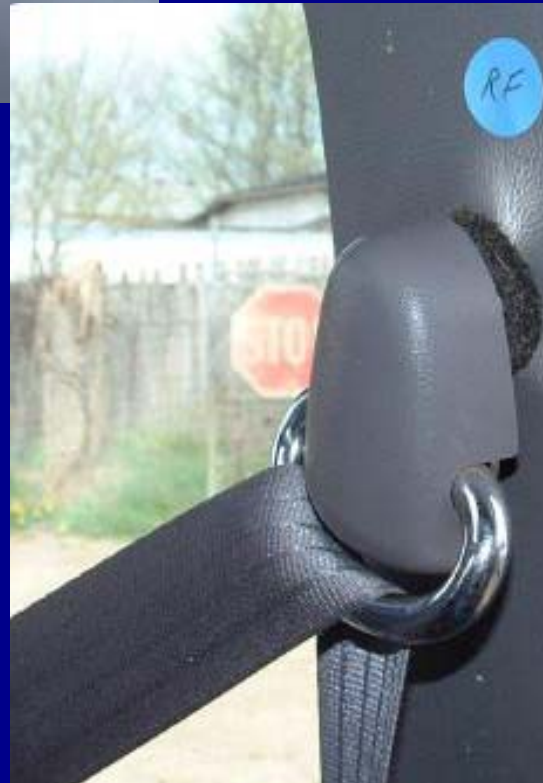
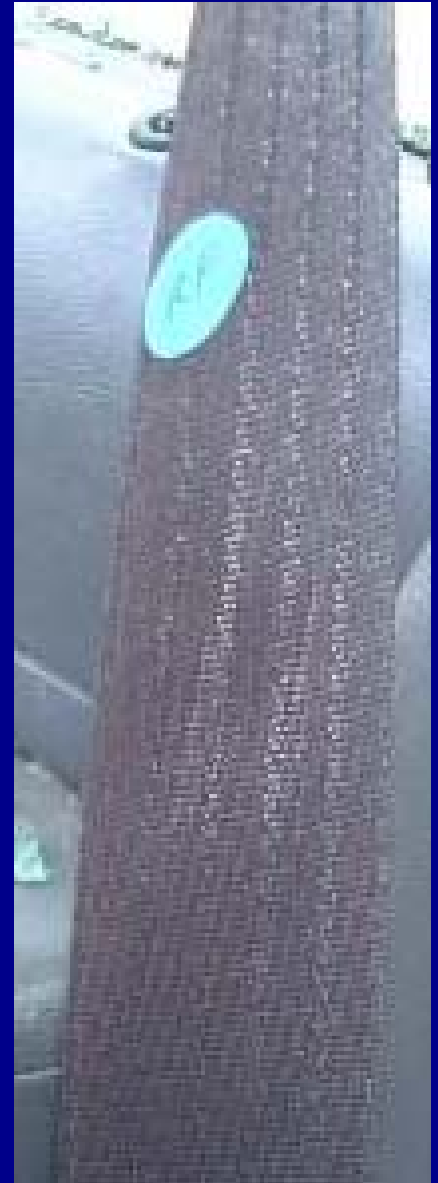
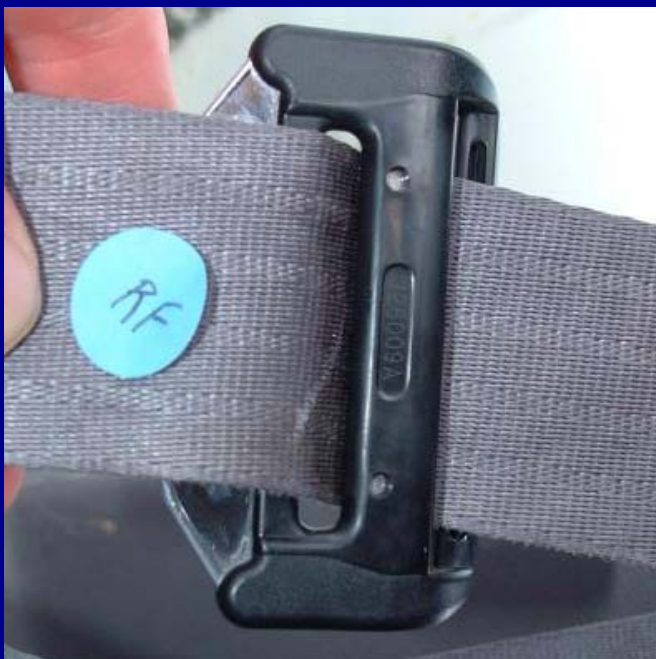
Right Front - 1994 Ford Explorer

- Right front
- 7-year-old female
- 4 ft 1 in tall
- 75 lb
- 3-point manual belt worn
- Intrusions
 - Toe pan 9 cm to rear
 - Floor pan 11 cm up

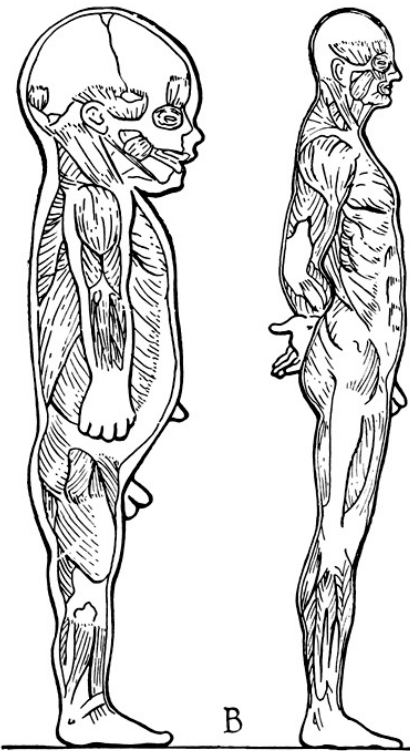
Right Lateral Views of the Newborn Infant and the Adult

This problem is worsened from the crash injury standpoint by the fact that an under-developed neck supports an oversized head. As shown in the following slide, the vertebrae of the neck are much weaker than in the adult, often containing cartilage that has not hardened into bone. The muscles of the neck are weak and under-developed, you see this yourself with young infants who can't hold up their heads. The ligaments binding the vertebrae together are also loose to accommodate growth. In a crash, a large amount of stress is placed on the under-developed neck and injuries can result.

Reconstructed to the Same Total (Crown-heel) Height or Stature

A. The Skeleton

B. The Musculature, Subcutaneous Tissue and Skin

C. The Major Visceral Mass and the Central Nervous System

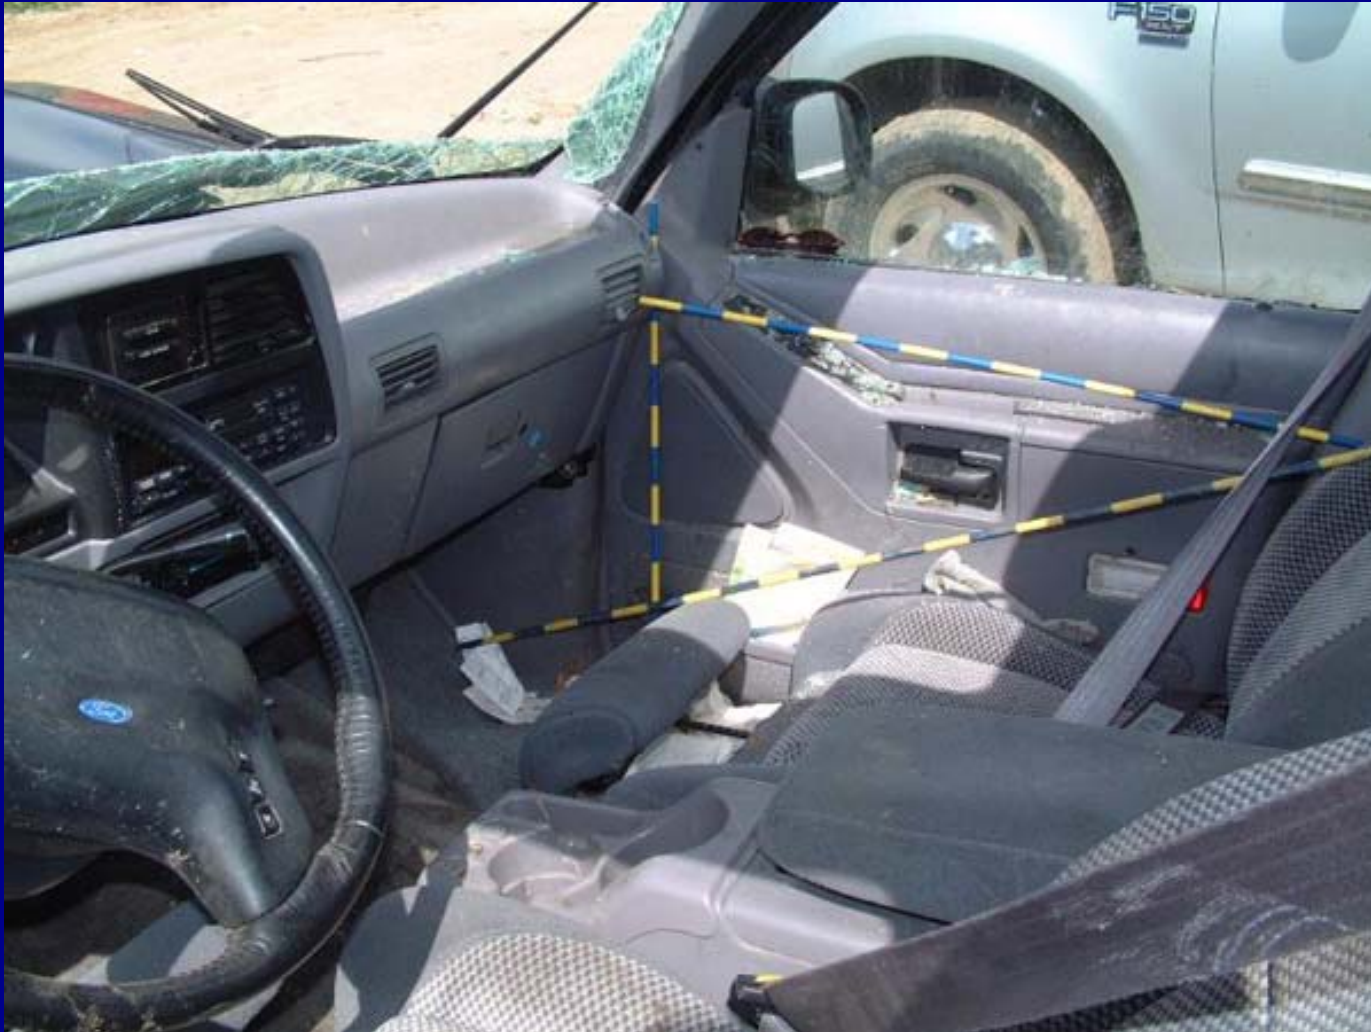
C: 7 year old Right Front Passenger

floor pan = 11 cm upward

toe pan = 9 cm rearward

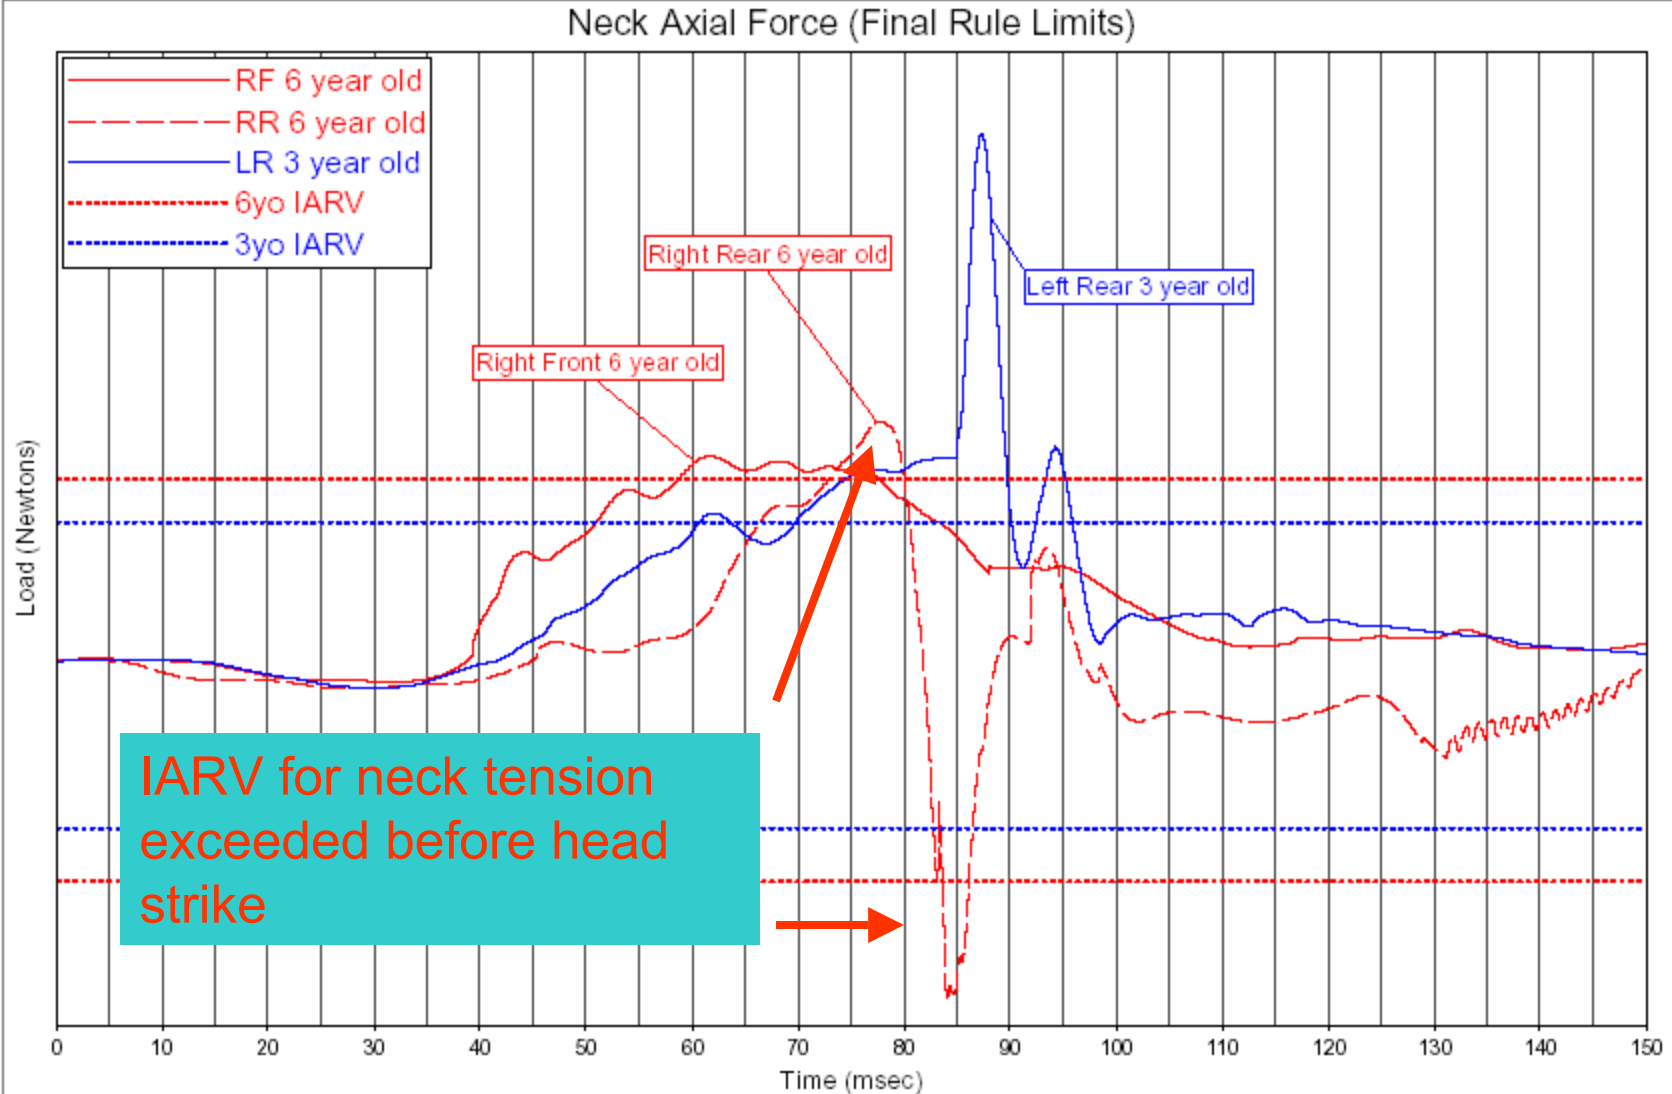
Neck Injury (Hybrid III ATDs)

- **MADYMO model** based on actual vehicle
- **Vehicle Environment (internal geometry)** obtained from previous simulations
- **Crash Pulse** obtained from NHTSA FMVSS 208 compliance test (30mph)
- **Occupants simulated** using Hybrid III 6 year old models for right rear and right front, Hybrid III 3 year old model for left rear
- **Finite Element Seat Belts** created to emulate reported belt conditions for 3 children in vehicle
